**EVALUATION AND COMPARISON OF
HURRICANE INDUCED DAMAGE TO
OFFSHORE GOM PIPELINES FROM
HURRICANE LILI**

**Prepared For
United States Department of the Interior
MINERALS MANAGEMENT SERVICE
Herndon, VA**

August 31, 2005

**Stress Engineering Services, Inc.
13800 Westfair East Drive
Houston, Texas 77041**

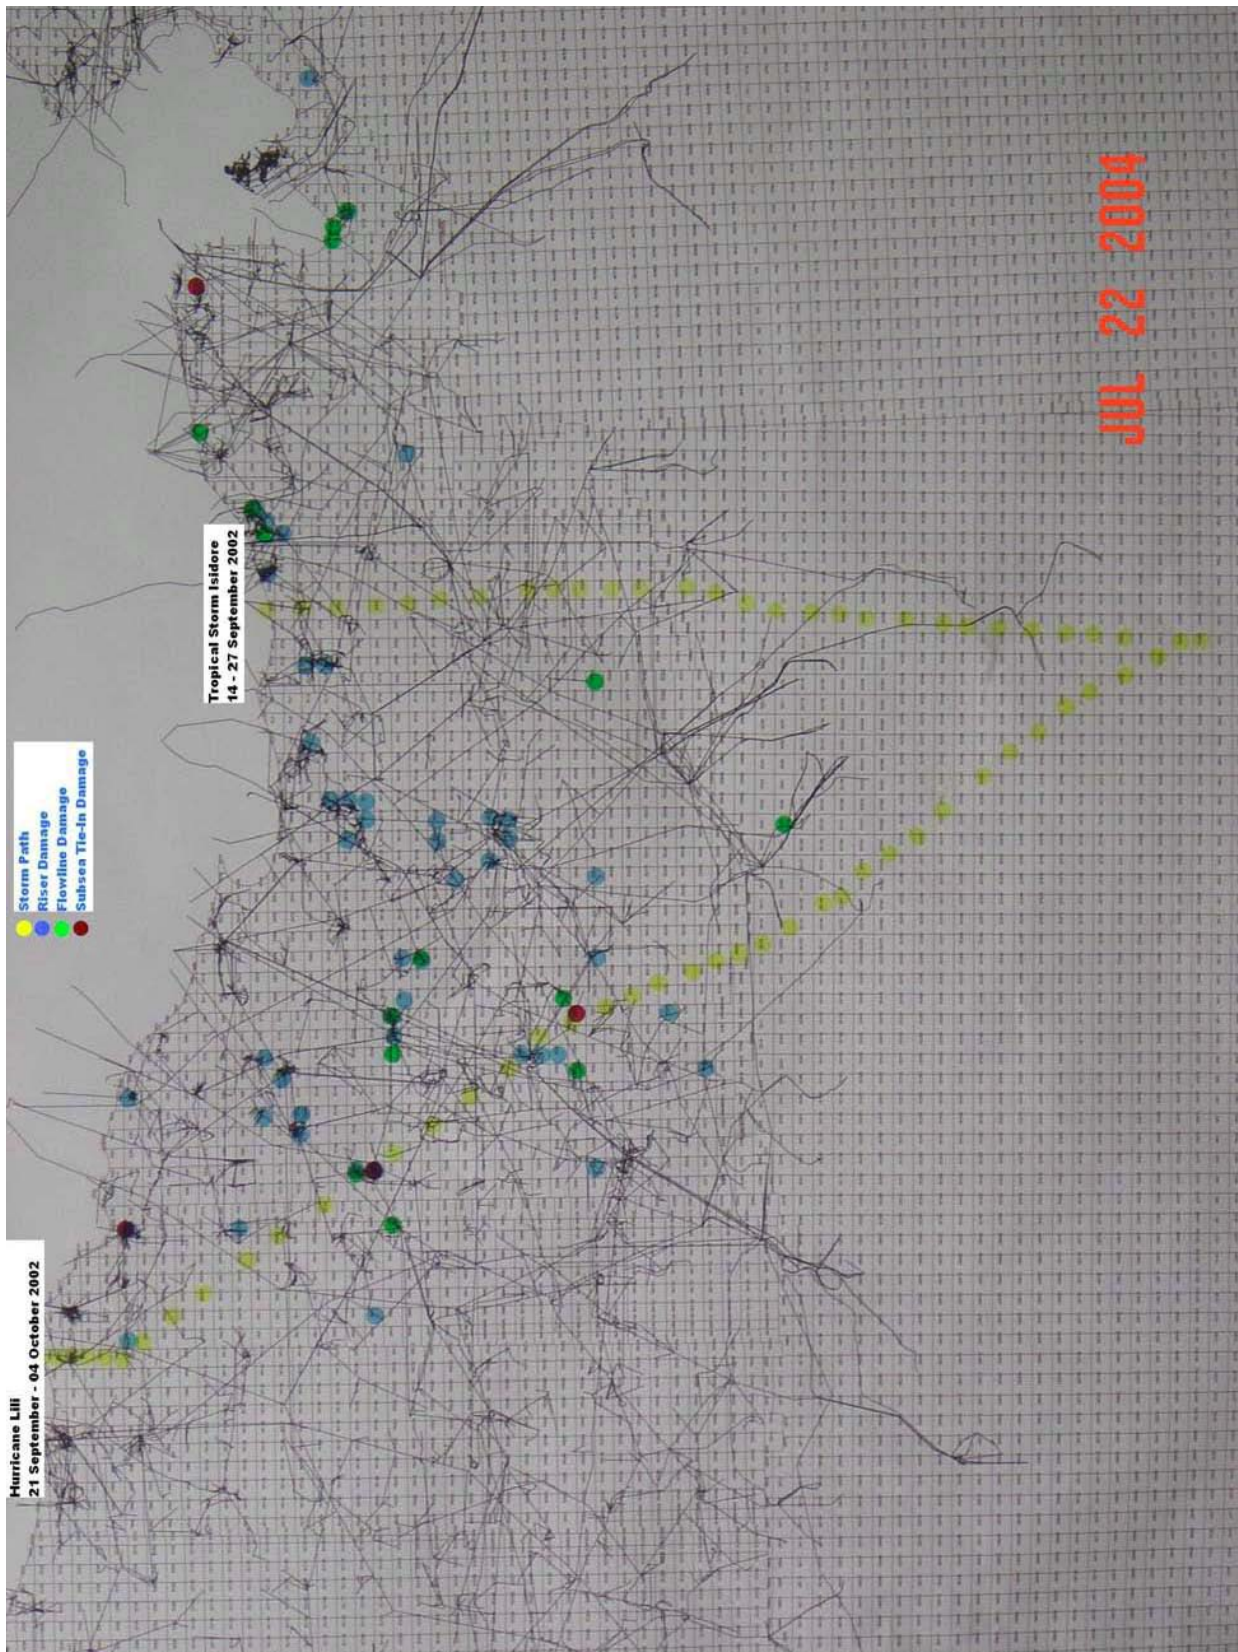
Figure 13. Storm Paths and Associated Damage.

As evident in the figure, the highest concentration of damage occurs east of Lili's path but west of Isidore. The path of destruction is consistent with data collected on hurricanes. Generally, hurricanes generate more powerful winds, waves, and currents to the east of the eye of the storm.

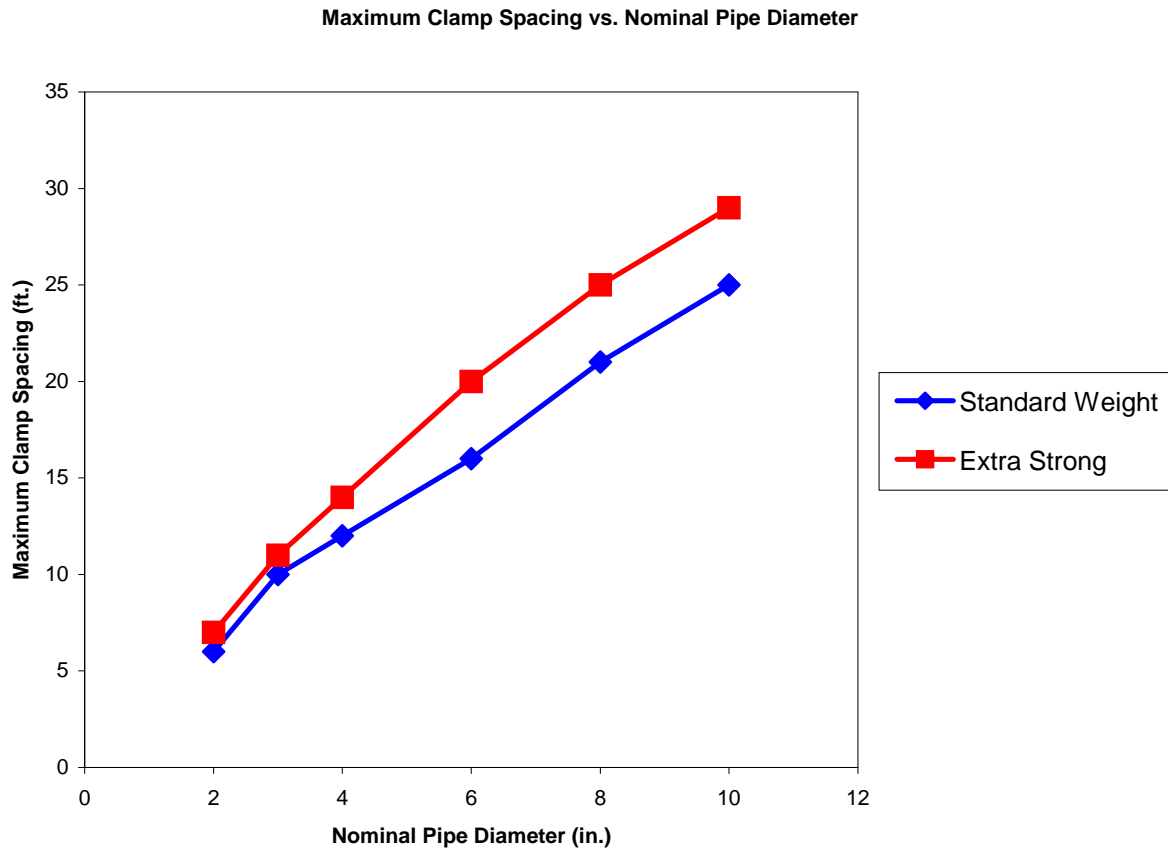
**Figure 19. Comparison of Maximum Clamp Spacing for
Standard and Extra-Strong Pipe**

A plot of these results is shown in Figure 19, and more details of the calculation results leading to Table 7 are included in Appendix D.

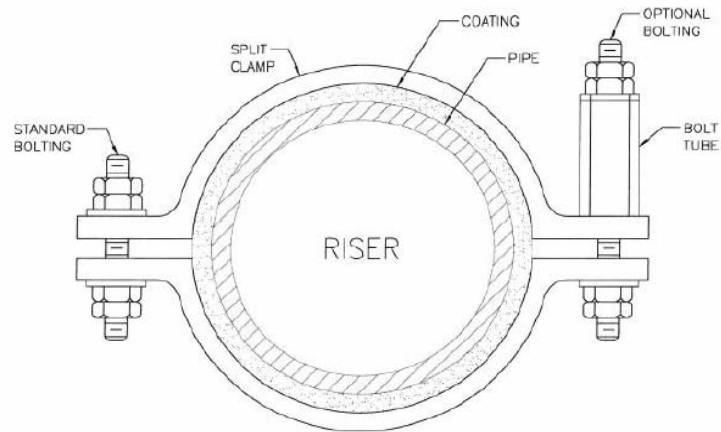
**Figure 20(a). Typical Existing Clamp Modification.
(If new Installation is not feasible)**

The most competent clamp is one that maintains a spring load force on the riser so that the riser, excited by wave forces and VIV will not “rattle”, or vibrate in the clamp. Split clamps, see Figure 20 for an example, must be carefully designed (sized) to fit around the coated clamp in such a way that the spring loading of the clamp in bending, the coating viscoelasticity and the bolt tension spring action come to play in maintaining a solid grip on the riser over time. If the bolts are torqued until the clamp flanges meet, the length of the bolt in tension is small, and the spring is not soft enough. This condition is depicted on the left side of

the clamp in the figure. If an old design is being fixed, a simple change is to add a "bolt tube" to one flange of the clamp so that the same torque on a bolt produces more spring action due to the increased length of bolt in tension. This change is shown on the right half of the clamp.
